DEPARTMENT OF TRANSPORTATION

Contract #: 04-0120F4Cty: SF/ALA Rte: 80 PM: 13.2/13.9File #: 69.28**WELDING INSPECTION REPORT****Resident Engineer:**Pursell, Gary**Address:** 333 Burma Road**City:** Oakland, CA 94607**Report No:** WIR-012604**Date Inspected:** 22-Feb-2010**Project Name:** SAS Superstructure**OSM Arrival Time:** 700**Prime Contractor:** American Bridge/Fluor Enterprises, a JV**OSM Departure Time:** 1900**Contractor:** Zhenhua Port Machinery Company, Ltd (ZPMC), Changxing Island **Location:** Shanghai, China

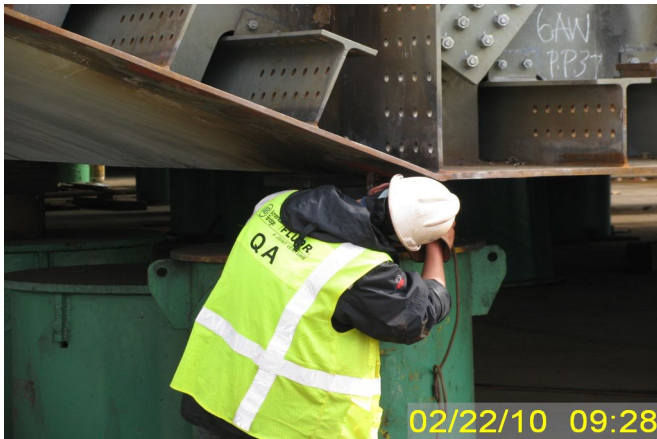
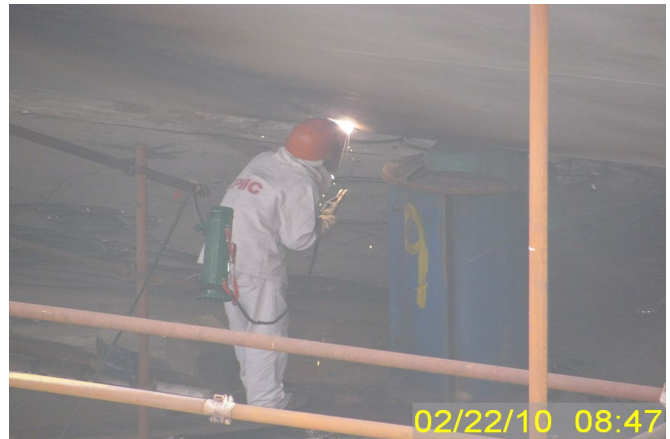
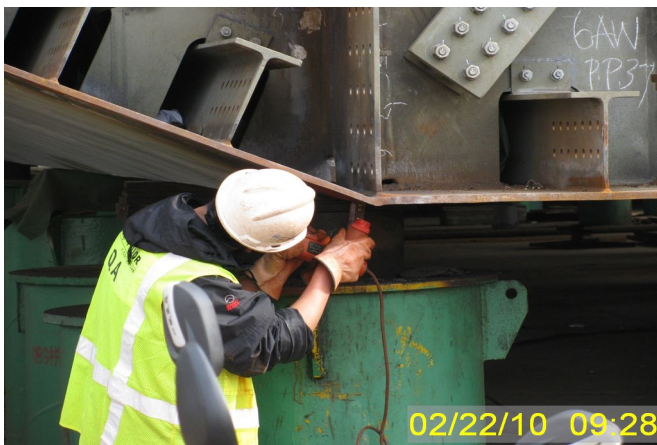
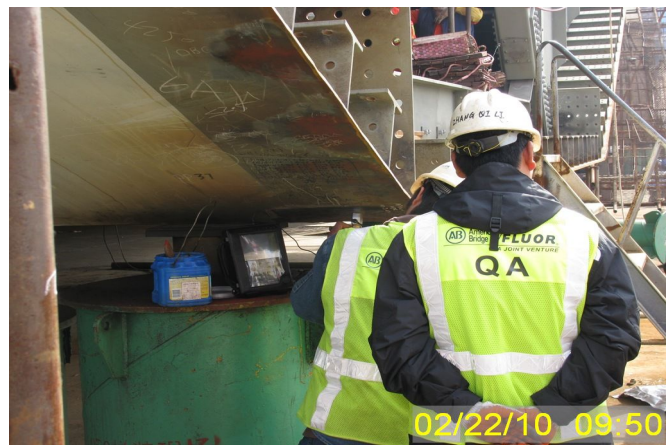
This inspector witnessed SMAW being performed on the 7AE to 7BE side plate transverse splice, counterweight side. These welds were identified as OBW7B-001 and OBW7B-002. The welder was identified as 068917. ZPMC QC was identified as Mr. Li Yang. The welding procedure used for this operation was identified as WPS-B-P-2214-B-U2-FCW-1.

This inspector witnessed trial fitup of the counter weight assembly on OBG segment 6CW.

This inspector witnessed SMAW being performed on the 7AW to 7BW side plate transverse splice, cross beam side. These welds were identified as OBE7B-001 and OBE7-002. The welder was identified as 067609. ZPMC QC was identified as Mr. Shen Jian Bo. The welding procedure used for this operation was identified as WPS-B-P-2214-B-U2.

section 6AW counter weight side LD. MT operator was identified as Mr. Huang Zheng Chao. One indication was noted in the cover pass by Mr. Chao.

This inspector witnessed Ultrasonic Testing, UT, by ABF after base metal repairs on section 6AW counter weight side LD. UT operator was identified as S007. No recordable indication was noted at the time of testing.

This inspector witnessed weld repairs in accordance with CWR 1098. The weld procedure used for these repairs was identified as WPS-345-SMAW-1G-(1F)-Repair. The ZPMC QC was identified as Mr. Zhong Yong Gang.

This inspector witnessed weld repairs in accordance with CWR 1138. The weld procedure used for these repairs was identified as WPS-345-SMAW-4G-(4F)-Repair-1. The ZPMC QC was identified as Mr. Zhong Guo Hui. The welder was identified as 069683.
